NUMBER
PI2002Y/Z

DATE
April 2021

PRODUCT IMPROVEMENT CAMPAIGN

**SUBJECT: ENGINE REPLACEMENT INSTRUCTIONS
FOR DTC P1326 (PI2002Y/Z)**

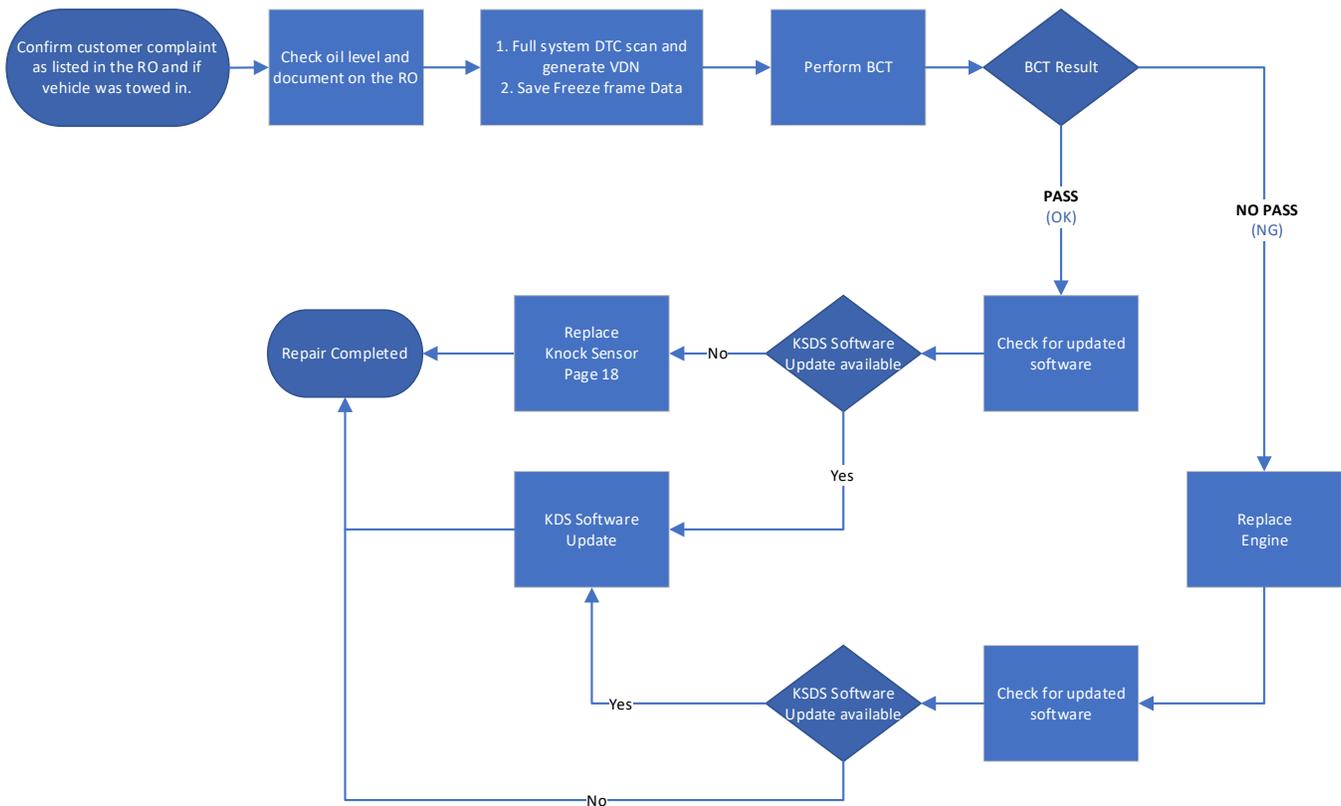
A. DTC P1326 STORED

Create PI2002Y Claim – No Techline PWA Required

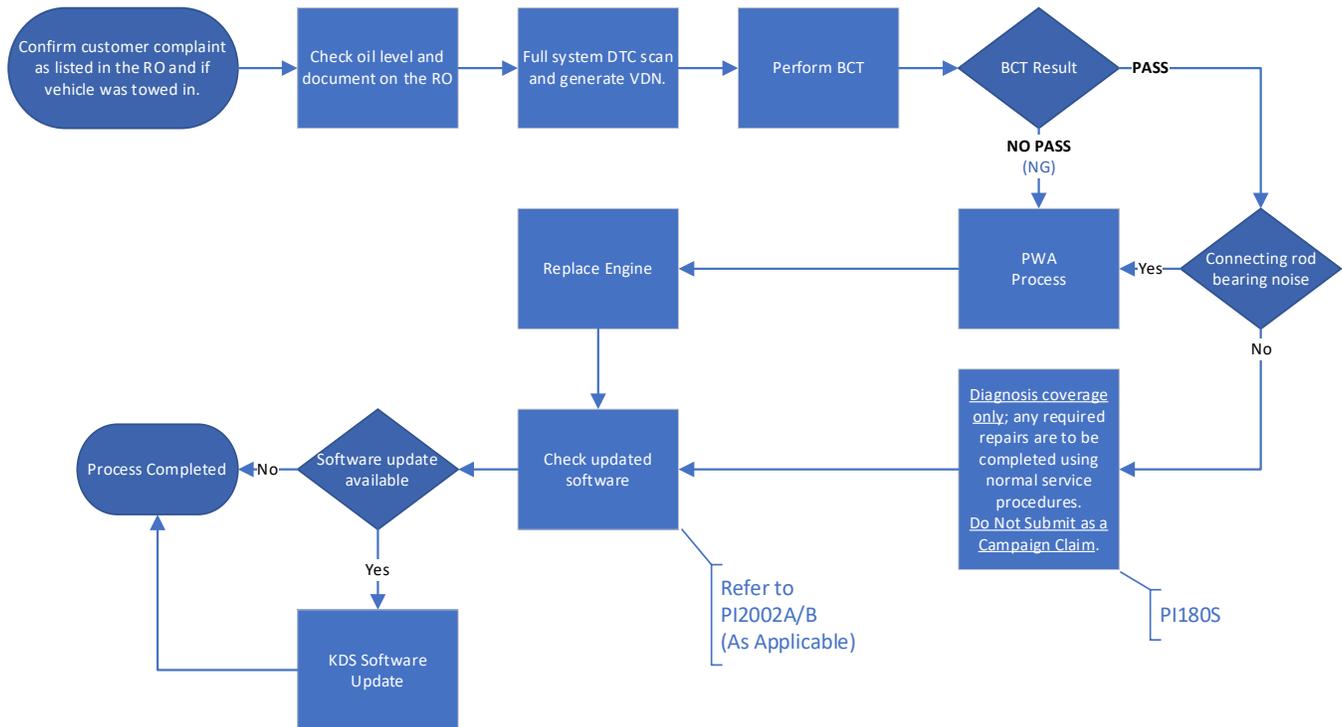
B. ENGINE NOISE

Techline PWA Required; Diagnosis only Campaign Possible

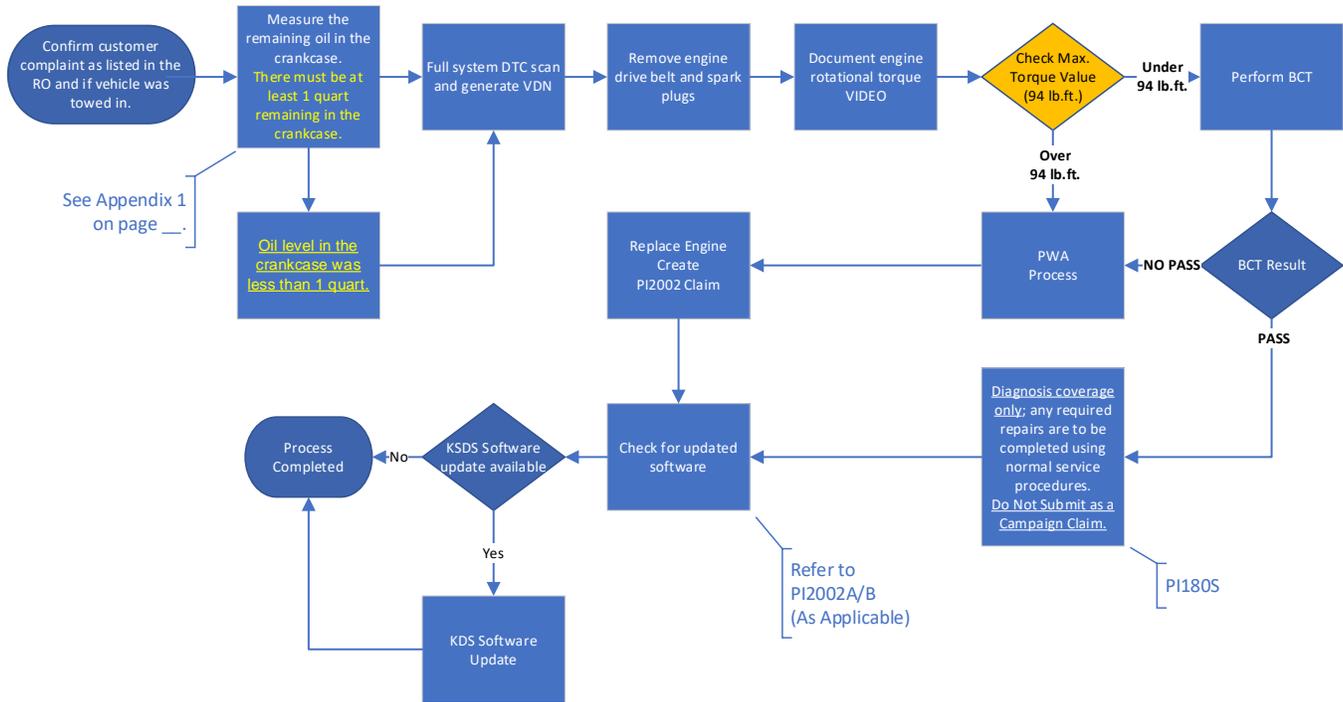
C. ENGINE NO CRANK

Techline PWA Required; Diagnosis only Campaign Possible
